TEST REPORT

No. : GZIN1812067993MR

Sample Name : (X) (X) ND(X)X-X 1ST&2ND&3RD X=ANY LETTER 4TH&5TH X=ANY
NUMBER

No.	Test Item	Test Method	Result	Conclusion
1	IP6X	IEC 60529:1989+A1:1999+A2:2013 COR2:2015 and client's requirement	No visual ingress of dust	Pass
2	IPX8	IEC 60529:1989+A1:1999+A2:2013 COR2:2015 and client's requirement	No visual ingress of water	Pass

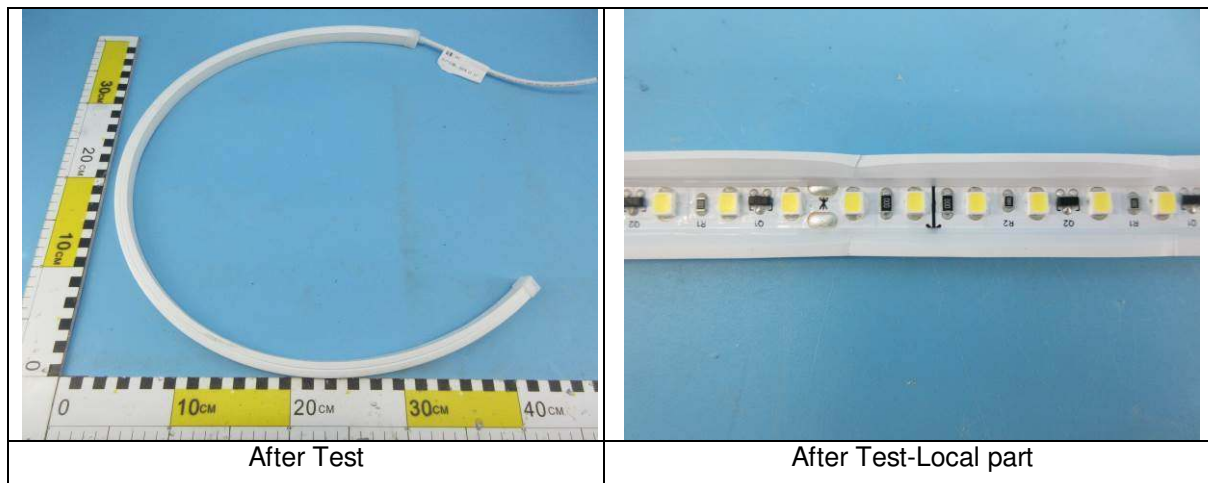
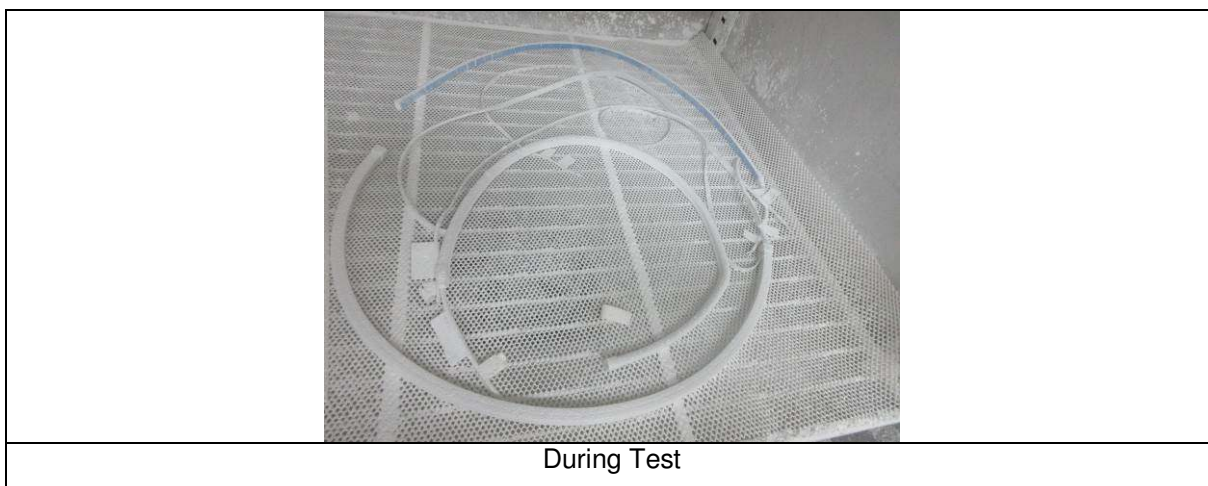
Test Photo:

Test Dust: Talcum powder

Dust Concentration: 2 kg/m³ chamber volume and be kept in suspension during the test

Test Duration: 8 hours

Sample	Result	Client's requirement	Conclusion
A-#1	No visual ingress of dust	No visual ingress of dust	Pass

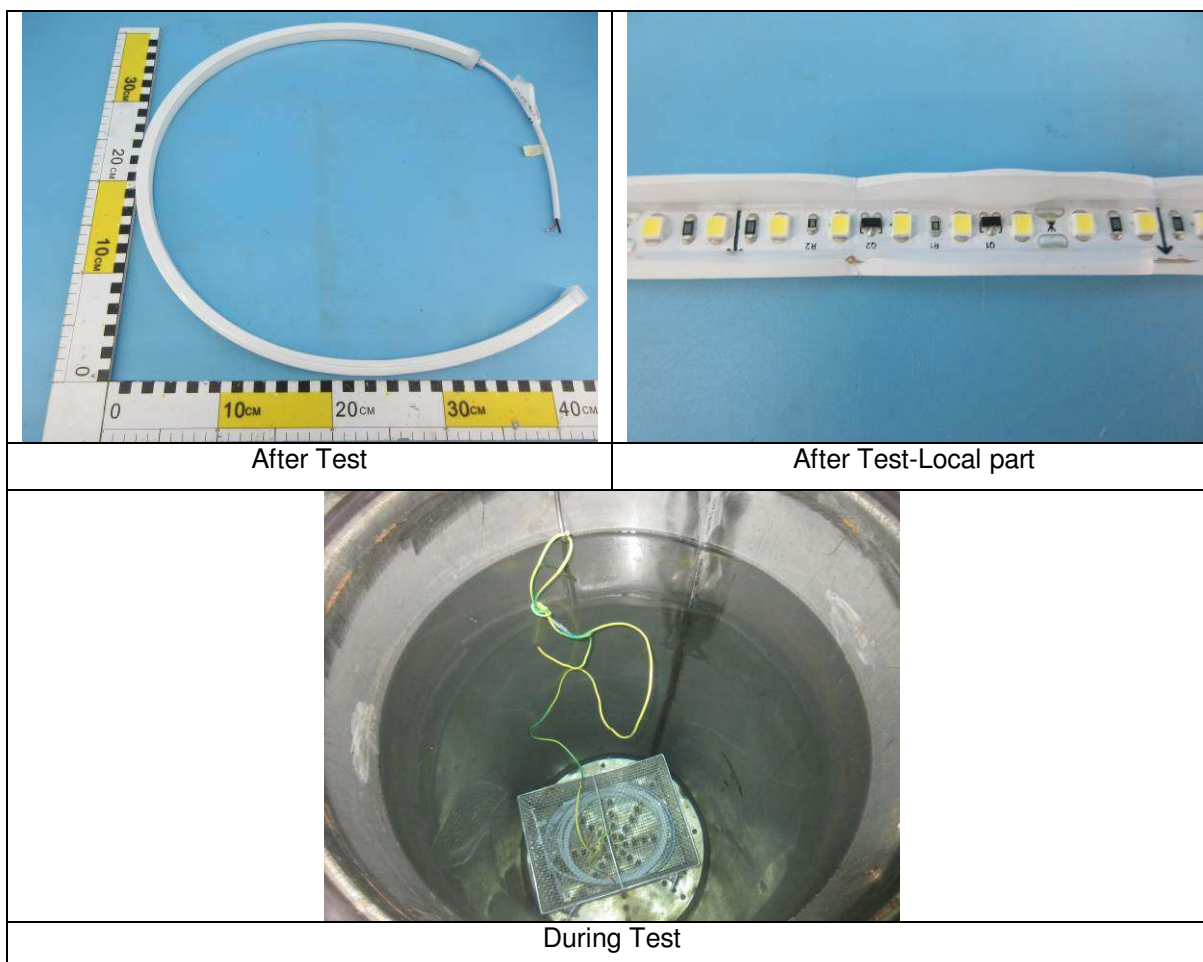
Test Photo:

Depth: 1.1m

Test duration: 1h

Sample	Result	Client's requirement	Conclusion
A-#2	No visual ingress of water	No visual ingress of water	Pass
