No.: SHIN2004019006MR

Sample Name N2-4

Test Item: IK 08

Sample Description: White sample Test Method: IEC 62262:2002

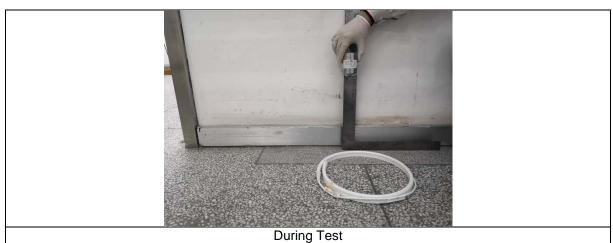
### Test Photo:

Impact type: Vertical hammer

Hammer quality: 1.7 kg Height of fall: 300 mm Impact energy: 5J

Impact number: 2 strokes

Sample No. Test Result		Test Requirement	Conclusion	
	After test, the appearance of	After test, the appearance of the		
4	the sample is not damaged,	sample is not damaged, and the	Pass	
ı	and the sample can be lighted	sample can be lighted under DC		
	under DC 24V.	24V.
