## TEST REPORT

No. : GZIN1907036890MR

Sample Name : B(X)(X)-(X)1ST&2ND&3RD X= ANY LETTER OR ANY NUMBER

Summary of Results:

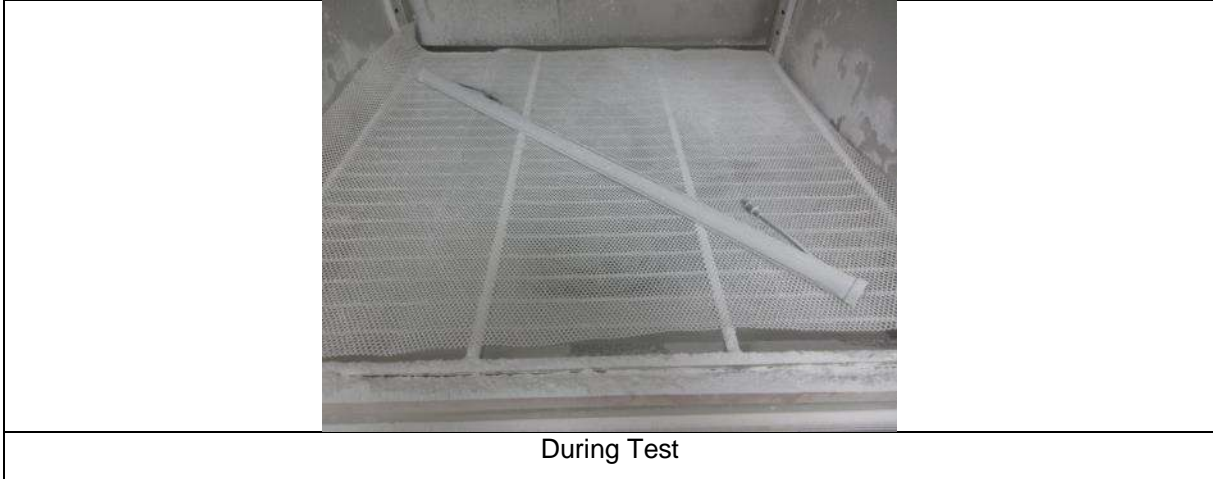
During Test

Equipment	Model	Equipment No.	Calibration date	Next Calibration date
Sand and dust test chamber	MS-SC-010	GZMR-RL-E119	2019-05-14	2020-05-13
